**Flood Control Project Maintenance  
Levee Inspections**

**Fall 2019 Levee Maintenance Deficiency Summary Report**

<b>RD0349</b>	Overall LMA Rating	Total LMA Miles						
<b>Reclamation District No. 0349 Sutter Island</b>	<b>U</b>	<b>12.41</b>						
Rated Item	Maintenance Deficiency				Enforcement		Design & System Obsolescence	
	M Miles	U Miles	M + 4U Miles	Threshold %	M Miles	U Miles	M Miles	U Miles
<i>Earthen Levee</i>								
Vegetation	5.48	3.84	20.84	167.97%	0.14	0.57		
Trim / Thin Trees	0.26	0.04	0.42	3.39%				
Encroachments	0.24		0.24	1.93%	1.04	0.29		
Animal Control	0.18		0.18	1.45%				
Slope Stability	0.01		0.01	0.08%				
Crown Surface / Depressions / Rutting	0.01		0.01	0.08%				
Flood Preparedness & Training	0.12		0.12	0.97%				
<i>Supplemental</i>								
2017 USACE Erosion Survey	0.35		0.35	2.82%				
DRAFT DWR UCIP Field Study					0.50	0.01		
2017 Storm Damage	0.22		0.22	1.77%				
<i>LMA Totals:</i>	6.87	3.88	22.39	180.46%	1.68	0.87	0.00	0.00

**Flood Control Project Maintenance  
Levee Inspections****LMA District Cover Sheet  
Fall 2019 Levee Inspection Results****Reclamation District No. 0349 Sutter Island**

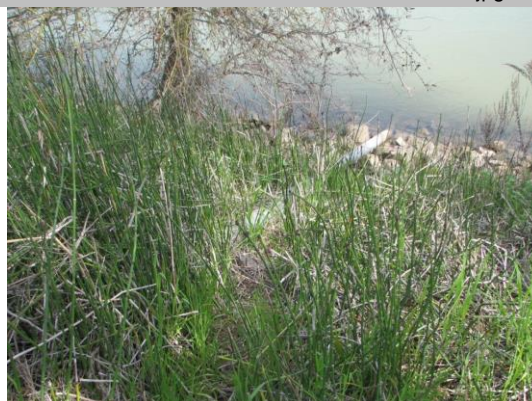
Photo 1 of 3 : UCIP\_FA\_2019\_21608\_36662.jpg

Comment Code					
Inspector Comment					
DS_ID:24156 FS_ID:21608 EP_NO: N/A Repair Type: Non-Urgent Crossing Status: Found UCIP Comments: Dense vegetation limits the inspector's visibility to identify signs of pipe failure (leaks) along the slope. Recommend removing vegetation along pipe alignment to conduct proper inspection of structure and appurtenances. Note date on photos should be 3/18/09 not 7/26/08 camera metadata is incorrect. FIELD_STRUCT_DESC: 10-inch steel irrigation pipe through the levee, 3.9 feet below the levee crown. Siphon breaker in concrete riser on the landside (LS) shoulder. Pump and gate valve in pump house on the waterside (WS) slope. [Additional Reference(s): DWR Levee Log, 2005. USACE Sacramento O&M Manual Unit No. 110, May 1959, revised 29 Dec 2016, (HLM 1.9)] FS Date: 3/18/2009

View of pipe on waterward slope.

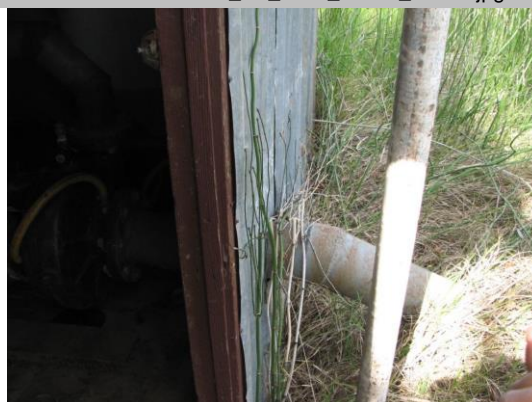
Photo 2 of 3 : UCIP\_FA\_2019\_21608\_36663.jpg

View of pipe daylight at shed on waterward side.

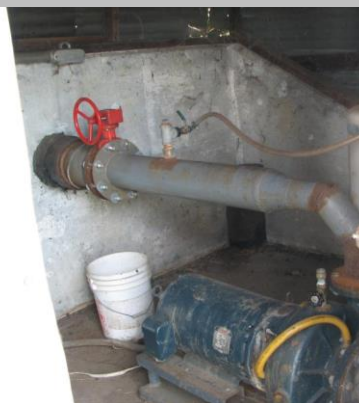
Photo 3 of 3 : UCIP\_FA\_2019\_21608\_36665.jpg

Comment Code						
Inspector Comment						
DS_ID:24156 FS_ID:21608 EP_NO: N/A Repair Type: Non-Urgent Crossing Status: Found UCIP Comments: Dense vegetation limits the inspector's visibility to identify signs of pipe failure (leaks) along the slope. Recommend removing vegetation along pipe alignment to conduct proper inspection of structure and appurtenances. Note date on photos should be 3/18/09 not 7/26/08 camera metadata is incorrect. FIELD_STRUCT_DESC: 10-inch steel irrigation pipe through the levee, 3.9 feet below the levee crown. Siphon breaker in concrete riser on the landside (LS) shoulder. Pump and gate valve in pump house on the waterside (WS) slope. [Additional Reference(s): DWR Levee Log, 2005. USACE Sacramento O&M Manual Unit No. 110, May 1959, revised 29 Dec 2016, (HLM 1.9)] FS Date: 3/18/2009

View inside pump house of pipe crossing coming out of levee.

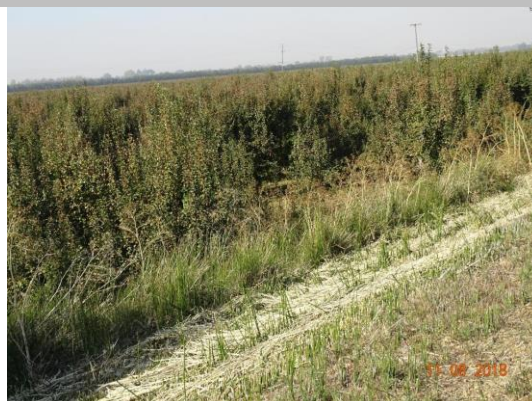
Photo 1 of 1 : FA\_2019\_RD0349\_205\_61\_20190826\_00044.jpg

LM Start	1.83	Rating **	M	Issue No.	61
LM End	1.89	Issue Type +	En	Location *	LS
Category	Earthen Levee			GPS Latitude/Longitude	
				Start	End
Item	Encroachments			38.283165 °	38.282357 °
				-121.589385 °	-121.589558 °
DWR ID	DWR_RD0349_02_f_2018_61				
Comment Code					
CR : Crops					
Inspector Comment

View of orchard trees on the landside toe (November 2018).

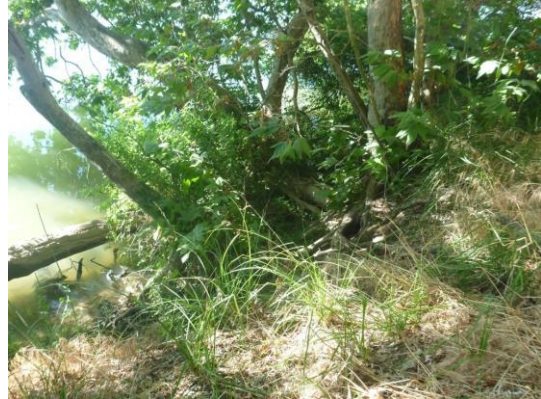
Photo 3 of 3 : FA\_2019\_RD0349\_205\_41\_20190826\_00029.jpg

LM Start	2.11	Rating **	A/W	Issue No.	41 (cont)
LM End	2.13	Issue Type +	Ma	Location *	
Category	Supplemental			GPS Latitude/Longitude	
				Start	End
Item	2017 Storm Damage			38.279039 °	38.278806 °
				-121.589664 °	-121.589783 °
DWR ID	LMA-151				
Comment Code					
Inspector Comment					
Levee Evaluation Comments					
Description:District Station 112+11 to 113+04, Sec. 13, T. 5 N. R. 3 E., M.D.M. Approximately 93 linear feet of erosion exists along the water side slope of Steamboat Slough (Unit 2). The erosion area commences approximately 3/4 of the way down the slope from the levee crown and extends to the waterside toe around existing trees. No rip rap is visible in this area.					
Site ID No:324					
Site Designation:LMA-151					
Repair Type: Erosion					
Rating:Serious					
Field Date:7/28/2017					
Notes: no berm

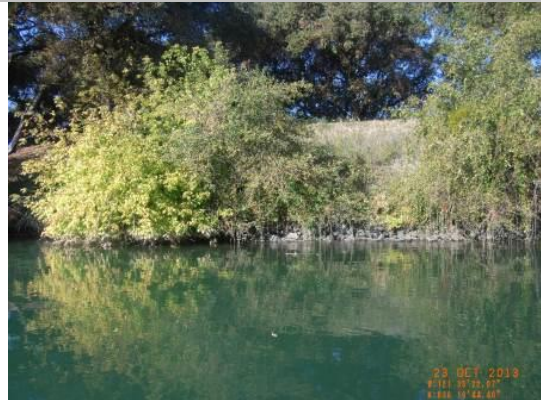
Photo 1 of 1 : FA\_2019\_RD0349\_205\_25\_20190826\_00010.jpg

LM Start	2.11	Rating **	A/W	Issue No.	25
LM End	2.14	Issue Type +	Ma	Location *	WS
Category	Supplemental			GPS Latitude/Longitude	
				Start	End
Item	2017 USACE Erosion Survey			38.279017 °	38.278597 °
				-121.589615 °	-121.589854 °
DWR ID	DWR_RD0349_02_f_2018_25				
Comment Code					
Inspector Comment					
2017 Site ID: STM 23.9 R					
Status: Eroding					
2017 Field Notes: No observed change.					
Site History: 1997 - Top right bank has retreated into the levee. Site is between two rock sites. 1999 - Downstream half of the reach repaired with rock. 2000 - Trees leaning into the water. 2010 - Site appears worse. 2011 - New erosion at the toe. 2013 - Short vertical sections observed at upstream end. 2015 - Minor new erosion.

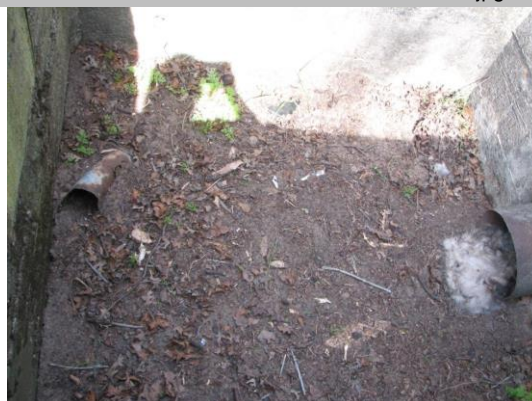
Photo 1 of 3 : UCIP\_FA\_2019\_21609\_36668.jpg

Comment Code					
Inspector Comment					
DS_ID:24157 FS_ID:21609 EP_NO: N/A Repair Type: Non-Urgent Crossing Status: Found UCIP Comments: Debris scattered--need to contact owner. If crossing to conduct proper inspection of structure and appurtenances. Note date on photos should be 3/18/09 not 7/26/08 camera metadata is incorrect. FIELD_STRUCT_DESC: 8-inch irrigation pipe of unknown material sleeved through 12-inch pipe through the levee, 4 feet below the levee crown. Annular gap not grouted. Service pole on the waterside (WS) shoulder. Pump on the WS. Concrete distribution box at landside (LS) toe. [Additional Reference(s): DWR Levee Log, 2005. USACE Sacramento O&M Manual Unit No. 110, May 1959, revised 29 Dec 2016, (HLM 2.3), 12-inch] FS Date: 3/18/2009

Inside view of distribution box located on landward side.

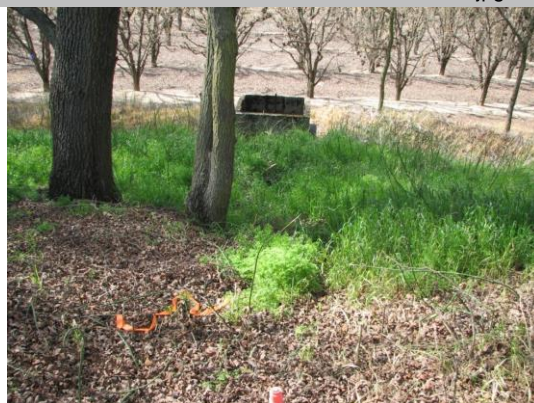
Photo 3 of 3 : UCIP\_FA\_2019\_21609\_36666.jpg

Comment Code						
Inspector Comment						
DS_ID:24157 FS_ID:21609 EP_NO: N/A Repair Type: Non-Urgent Crossing Status: Found UCIP Comments: Debris scattered--need to contact owner. If crossing is not in used will need to coordinate with DWR Inspector and CVFPB to remove per Title 23 requirements. Dense vegetation limits the inspector's visibility to identify signs of pipe failure (leaks) along the slope. Recommend removing vegetation along pipe alignment to conduct proper inspection of structure and appurtenances. Note date on photos should be 3/18/09 not 7/26/08 camera metadata is incorrect. FIELD_STRUCT_DESC: 8-inch irrigation pipe of unknown material sleeved through 12-inch pipe through the levee, 4 feet below the levee crown. Annular gap not grouted. Service pole on the waterside (WS) shoulder. Pump on the WS. Concrete distribution box at landside (LS) toe. [Additional Reference(s): DWR Levee Log, 2005. USACE Sacramento O&M Manual Unit No. 110, May 1959, revised 29 Dec 2016, (HLM 2.3), 12-inch] FS Date: 3/18/2009

Overview of landward side--distribution box located at toe.

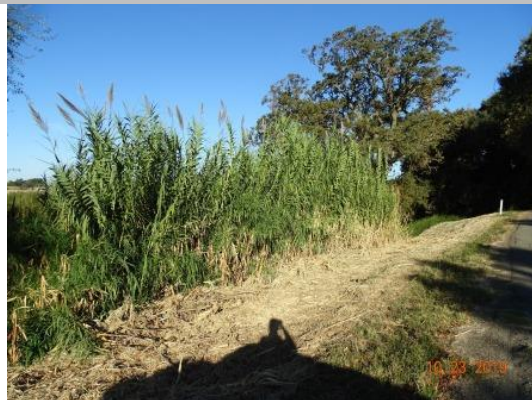
Photo 1 of 1 : FA\_2019\_RD0349\_205\_60\_20191025\_00129.jpg

LM Start	2.37	Rating **	U	Issue No.	60
LM End	2.39	Issue Type +	Ma	Location *	LS
Category	Earthen Levee			GPS Latitude/Longitude	
				Start	End
Item	Vegetation			38.275713 °	38.275435 °
				-121.591369 °	-121.591177 °
DWR ID	DWR_RD0349_02_f_2017_60				
Comment Code					
V2 : Remove the wild growth other than native grasses from the levee slopes.					
Inspector Comment					
Arundo

View looking upstream at arundo on the landside slope (Fall 2019).

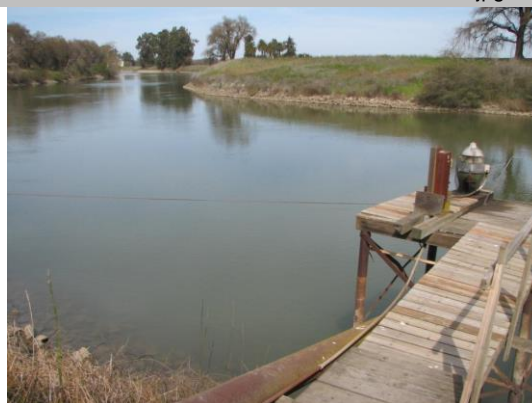
Photo 1 of 3 : UCIP\_FA\_2019\_39873\_36678.jpg

Comment Code					
Inspector Comment					
DS_ID:24158 FS_ID:39873 EP_NO: N/A Repair Type: Non-Urgent Crossing Status: Found UCIP Comments: Dense vegetation limit the inspector's visibility to identify signs of pipe failure (leaks) through the levee slopes. Recommend removing vegetation along pipe alignment to conduct proper inspection of structure and appurtenances. FIELD_STRUCT_DESC: 12-inch steel irrigation pipe through the levee, 4 feet below the levee crown. Pump on pile structure on waterside (WS), walkway to pump. Concrete distribution box and power pole with anchor at landside (LS) toe. Concrete standpipe on LS. (12-inch pipe authorized under Permit No. 946, 1944 - F. J. Mcquaid). [Additional Reference(s): DWR Levee Log, 2005. USACE Sacramento O&M Manual Unit No. 110, May 1959, revised 29 Dec 2016, (HLM 2.5)] FS Date: 3/18/2009

View of waterward side--pump and control panel located on raised platform.

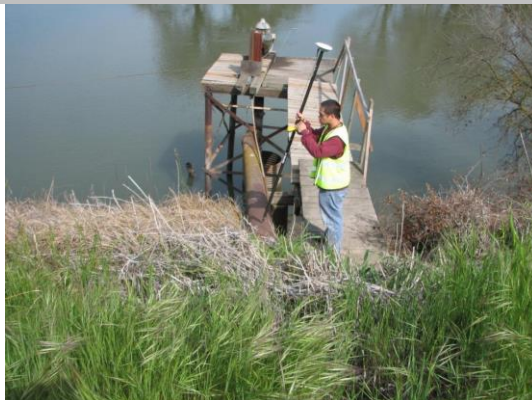
Photo 2 of 3 : UCIP\_FA\_2019\_39873\_36676.jpg

Comment Code						
Inspector Comment						
DS_ID:24158 FS_ID:39873 EP_NO: N/A Repair Type: Non-Urgent Crossing Status: Found UCIP Comments: Dense vegetation limit the inspector's visibility to identify signs of pipe failure (leaks) through the levee slopes. Recommend removing vegetation along pipe alignment to conduct proper inspection of structure and appurtenances. FIELD_STRUCT_DESC: 12-inch steel irrigation pipe through the levee, 4 feet below the levee crown. Pump on pile structure on waterside (WS), walkway to pump. Concrete distribution box and power pole with anchor at landside (LS) toe. Concrete standpipe on LS. (12-inch pipe authorized under Permit No. 946, 1944 - F. J. Mcquaid). [Additional Reference(s): DWR Levee Log, 2005. USACE Sacramento O&M Manual Unit No. 110, May 1959, revised 29 Dec 2016, (HLM 2.5)] FS Date: 3/18/2009

Overview of waterward side--dense vegetation limits slope inspection.

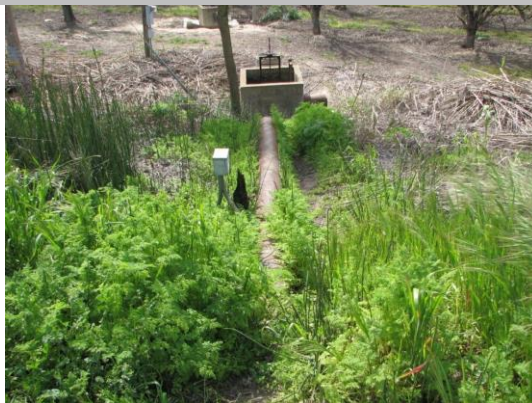
Photo 3 of 3 : UCIP\_FA\_2019\_39873\_36673.jpg

View of landward side--2 distribution boxes are located along pipe alignment.

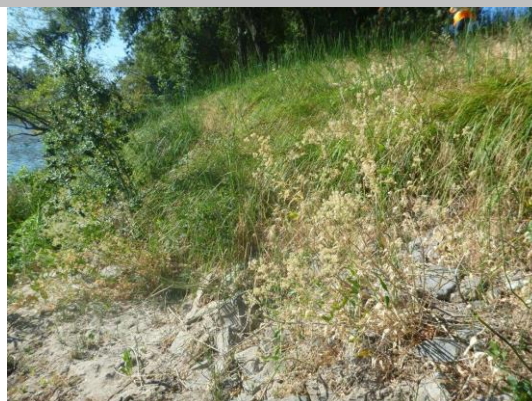
Photo 2 of 3 : FA\_2019\_RD0349\_205\_43\_20190826\_00033.jpg

LM Start	2.56	Rating **	A/W	Issue No.	43 (cont)	
LM End	2.59	Issue Type +	Ma	Location *		
Category	Supplemental			GPS Latitude/Longitude		
				Start	End	
Item	2017 Storm Damage			38.273769 °	38.273386 °	
				-121.588742 °	-121.588672 °	
DWR ID	LMA-153					
Comment Code						
Inspector Comment						
Levee Evaluation Comments						
Description:District Station 135+81 to 137+00, Sec. 13, T. 5 N. R. 3 E., M.D.M. Approximately 119 linear feet of sloughing exists due to scour along the water side toe of Steamboat Slough (Unit 2). The erosion area commences approximately 3/4 of the way down the slope from the levee crown and extends to the waterside toe. No rip rap is visible in this area.						
Site ID No:326						
Site Designation:LMA-153						
Repair Type: Erosion						
Rating:Area of Concern						
Field Date:7/28/2017						
Notes: no berm

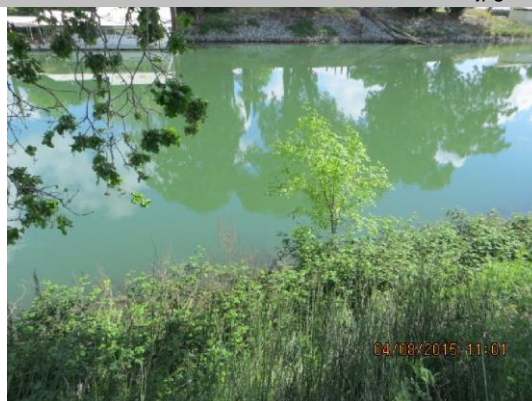
Photo 1 of 3 : UCIP\_FA\_2019\_44328\_73707.jpg

LM Start	2.93	Rating **	M	Issue No.	124	
LM End	2.93	Issue Type +	En	Location *		
Category	Supplemental			GPS Latitude/Longitude		
				Start	End	
Item	DRAFT DWR UCIP Field Study			38.268674 °	38.268674 °	
				-121.589419 °	-121.589419 °	
DWR ID	24159					
Comment Code						
Inspector Comment						
DS_ID:24159 FS_ID:44328 EP_NO: N/A Repair Type: Non-Urgent Crossing Status: Found UCIP Comments: Pipe appears abandoned and should be done so properly. FIELD_STRUCT_DESC: *ABANDONED* 6-inch irrigation pipe of unknown material through the levee, 1.5 feet below the levee crown. [Additional Reference(s): DWR Levee Log, 2005. USACE Sacramento O&M Manual Unit No. 110, May 1959, revised 29 Dec 2016, (HLM 3.1)] FS Date: 4/8/2015

Pipe visible in water at WS toe.

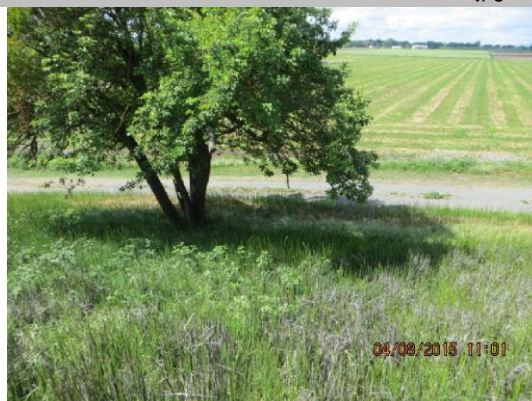
Photo 3 of 3 : UCIP\_FA\_2019\_44328\_73705.jpg

LM Start	2.93	Rating **	M	Issue No.	124 (cont)	
LM End	2.93	Issue Type +	En	Location *		
Category	Supplemental			GPS Latitude/Longitude		
				Start	End	
Item	DRAFT DWR UCIP Field Study			38.268674 °	38.268674 °	
				-121.589419 °	-121.589419 °	
DWR ID	24159					
Comment Code						
Inspector Comment						
DS_ID:24159 FS_ID:44328 EP_NO: N/A Repair Type: Non-Urgent Crossing Status: Found UCIP Comments: Pipe appears abandoned and should be done so properly. FIELD_STRUCT_DESC: *ABANDONED* 6-inch irrigation pipe of unknown material through the levee, 1.5 feet below the levee crown. [Additional Reference(s): DWR Levee Log, 2005. USACE Sacramento O&M Manual Unit No. 110, May 1959, revised 29 Dec 2016, (HLM 3.1)] FS Date: 4/8/2015

No pipe visible on LS toe.

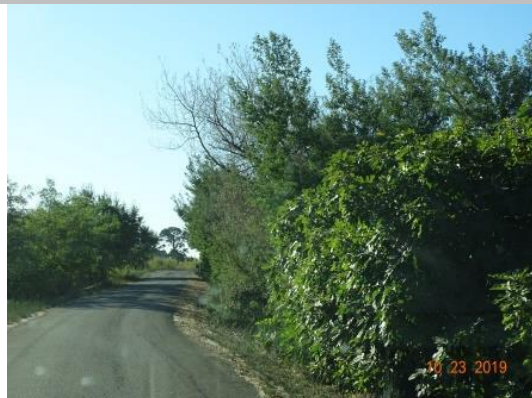
Photo 1 of 1 : FA\_2019\_RD0349\_205\_80\_20191025\_00130.jpg

LM Start	2.99	Rating **	U	Issue No.	80
LM End	3.05	Issue Type +	En	Location *	LS
Category	Earthen Levee			GPS Latitude/Longitude	
				Start	End
Item	Vegetation			38.267938 °	38.267004 °
				-121.588922 °	-121.588470 °
DWR ID	DWR_RD0349_02_s_2018_80				
Comment Code					
V6 : Landscaping					
Inspector Comment					
Dense landscape vegetation and trees should be thinned or removed to allow inspection and access.

View looking downstream at landscaping on the landside slope (Fall 2019).

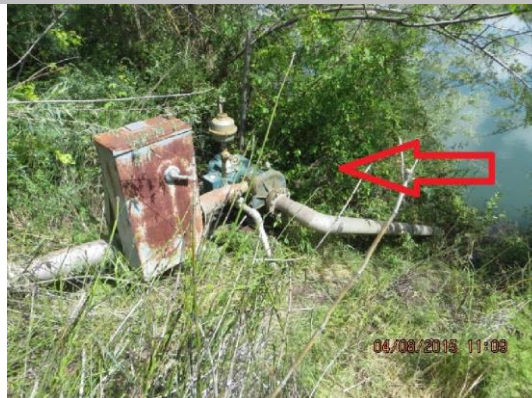
Photo 1 of 3 : UCIP\_FA\_2019\_53344\_73709.jpg

UCIP Comments: 7/24/2018 Same as last inspection. Dense vegetation on LS made inspection not accessible. WS pump and pipes, and electrical box, look operational. Contact owner to see if in operation; otherwise have abandoned properly. Crossing remains Urgent due to concern of internal levee integrity from corroded pipe (DWR UCIP - D. Sanoski).8/17/2016 Dense vegetation limits the inspector's visibility to inspect levee section along pipe alignment. Previous inspection indicates holes visible on pipe wall. Need to contact owner to notify that pipe needs to be abandoned properly per Title 23 requirements. (DWR UCIP - omagana)4/8/2015 Pipe visible on WS slope and appears to be open. Pipe needs to be properly abandoned or verified as having been done so properly. (DWR UCIP - omagana)

FIELD\_STRUCT\_DESC: \*ABANDONED\* 6-inch steel siphon irrigation pipe through the levee, 3.7 feet below the crown. Pump on concrete blocks on the waterside (WS) slope. 2-inch galvanized conduit is buried along side of the 6-inch pipe. PG&E service was installed on the landside (LS). (6-inch pipe authorized under Permit No. 5350, 1966 - Enver Salman; 6-inch pipe replaced previous 8-inch pipe authorized under Permit No. 655, 1935 - M. S. Salman) [Additional Reference(s): USACE San Joaquin O&M Manual Unit No. 110, May 1959, HLM 3.2, Drawing No. 50-4-3042; unable to confirm if 8-inch pipe is the same pipe listed in the USACE O&M manual as HLM 3.2].

Abandoned pipe visible on slope in vegetation behind new pipe on WS slope.

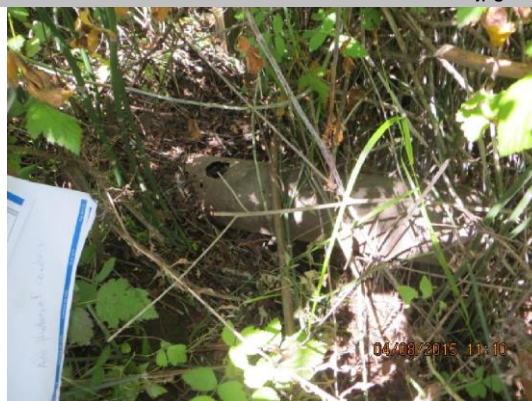
Photo 2 of 3 : UCIP\_FA\_2019\_53344\_73708.jpg

Item	DRAFT DWR UCIP Field Study		38.267471 °	38.267471 °								
			-121.588659 °	-121.588659 °								
DWR ID	24160											
Comment Code												
Inspector Comment												
DS_ID:24160 FS_ID:53344 EP_NO: 655 Repair Type: Urgent Crossing Status: Found UCIP Comments: 7/24/2018 Same as last inspection. Dense vegetation on LS made inspection not accessible. WS pump and pipes, and electrical box, look operational. Contact owner to see if in operation; otherwise have abandoned properly. Crossing remains Urgent due to concern of internal levee integrity from corroded pipe (DWR UCIP - D. Sanoski).8/17/2016 Dense vegetation limits the inspector's visibility to inspect levee section along pipe alignment. Previous inspection indicates holes visible on pipe wall. Need to contact owner to notify that pipe needs to be abandoned properly per Title 23 requirements. (DWR UCIP - omagana)4/8/2015 Pipe visible on WS slope and appears to be open. Pipe needs to be properly abandoned or verified as having been done so properly. (DWR UCIP - omagana) FIELD_STRUCT_DESC: *ABANDONED* 6-inch steel siphon irrigation pipe through the levee, 3.7 feet below the crown. Pump on concrete blocks on the waterside (WS) slope. 2-inch galvanized conduit is buried along side of the 6-inch pipe. PG&E service was installed on the landside (LS). (6-inch pipe authorized under Permit No. 5350, 1966 - Enver Salman; 6-inch pipe replaced previous 8-inch pipe authorized under Permit No. 655, 1935 - M. S. Salman) [Additional Reference(s): USACE San Joaquin O&M Manual Unit No. 110, May 1959, HLM 3.2, Drawing No. 50-4-3042; unable to confirm if 8-inch pipe is the same pipe listed in the USACE O&M manual as HLM 3.2]. FS Date: 7/24/2018 3:59:00 PM

Abandoned pipe visible on slope in vegetation behind new pipe on WS slope.

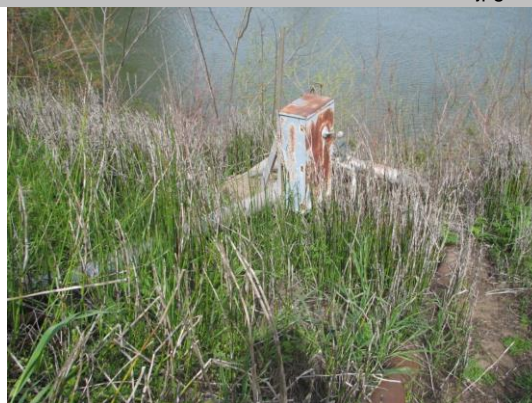
Photo 1 of 3 : UCIP\_FA\_2019\_44332\_36679.jpg

Comment Code					
Inspector Comment					
DS_ID:24199 FS_ID:44332 EP_NO: 5350 Repair Type: Non-Urgent Crossing Status: Found UCIP Comments: Need to contact owner to determine if crossing is still in use. If crossing is no longer in use owner will need to coordinate with DWR inspector and CVFPB to remove according to Title 23 requirements. Debris scattered on slopes--remove. Dense vegetation limits the inspector's visibility to identify signs of pipe failure (leaks) along the slope. Recommend removing vegetation along pipe alignment to conduct proper inspection of structure and appurtenances. Unable to determine if crossing is in use. Note date on photos should be 3/18/09 not 7/26/08 camera metadata is incorrect. FIELD_STRUCT_DESC: 6-inch steel irrigation pipe and 2-inch iron electrical conduit through the levee, 3.7 feet below the levee crown. Siphon breaker in pipe riser on waterside (WS) slope. Pump, switch panel, and butterfly valve on concrete blocks on the WS slope. Service pole on landside (LS) slope. (remove existing 8-inch water pipe and reinstall new 8-inch pipe and 2-inch electrical power conduit authorized under Permit No. 5350, 1966 - Enver Salman, 6-inch pipe installed and not 8-inch, refer to Inspector's notes page 9 of 27). [Additional Reference(s): DWR Levee Log, 2005] FS Date: 4/8/2015

View of waterward side--control panel, pipe, pump, and butterfly valve on WS slope.

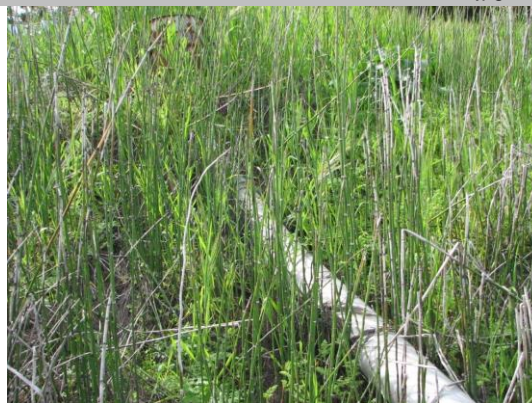
Photo 2 of 3 : UCIP\_FA\_2019\_44332\_36681.jpg

Pipe and Steel riser on WS slope.

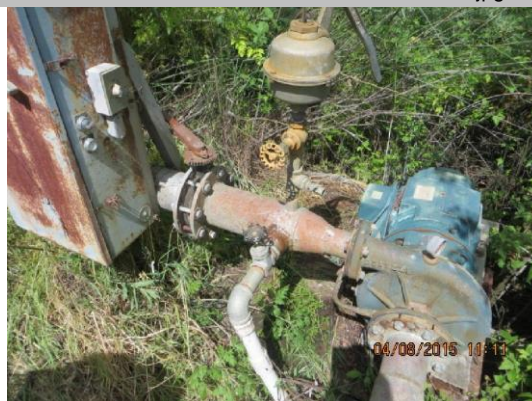
Photo 3 of 3 : UCIP\_FA\_2019\_44332\_73710.jpg

Item	DRAFT DWR UCIP Field Study		38.267453 °	38.267453 °								
			-121.588668 °	-121.588668 °								
DWR ID	24199											
Comment Code												
Inspector Comment												
DS_ID:24199 FS_ID:44332 EP_NO: 5350 Repair Type: Non-Urgent Crossing Status: Found UCIP Comments: Need to contact owner to determine if crossing is still in use. If crossing is no longer in use owner will need to coordinate with DWR inspector and CVFPB to remove according to Title 23 requirements. Debris scattered on slopes--remove. Dense vegetation limits the inspector's visibility to identify signs of pipe failure (leaks) along the slope. Recommend removing vegetation along pipe alignment to conduct proper inspection of structure and appurtenances. Unable to determine if crossing is in use. Note date on photos should be 3/18/09 not 7/26/08 camera metadata is incorrect. FIELD_STRUCT_DESC: 6-inch steel irrigation pipe and 2-inch iron electrical conduit through the levee, 3.7 feet below the levee crown. Siphon breaker in pipe riser on waterside (WS) slope. Pump, switch panel, and butterfly valve on concrete blocks on the WS slope. Service pole on landside (LS) slope. (remove existing 8-inch water pipe and reinstall new 8-inch pipe and 2-inch electrical power conduit authorized under Permit No. 5350, 1966 - Enver Salman, 6-inch pipe installed and not 8-inch, refer to Inspector's notes page 9 of 27). [Additional Reference(s): DWR Levee Log, 2005] FS Date: 4/8/2015

Butterfly valve next to, electrical panel, pump, and hand pump on WS slope.

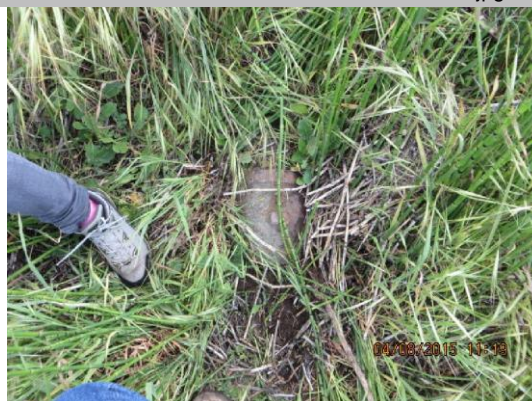
Photo 1 of 3 : UCIP\_FA\_2019\_46172\_74553.jpg

LM Start	3.15	Rating **	M	Issue No.	127	
LM End	3.15	Issue Type +	En	Location *		
Category	Supplemental			GPS Latitude/Longitude		
				Start	End	
Item	DRAFT DWR UCIP Field Study			38.265608 °	38.265608 °	
				-121.588391 °	-121.588391 °	
DWR ID	25099					
Comment Code						
Inspector Comment						
DS_ID:25099						
FS_ID:46172						
EP_NO: N/A						
Repair Type: Non-Urgent						
Crossing Status: Found						
UCIP Comments: Appears abandoned and if so should be verified as having been done so properly.						
FIELD_STRUCT_DESC: *ABANDONED* 6-inch pipe of unknown material or purpose through the levee, 4.5 feet below the levee crown.						
Service pole at landside (LS) toe.						
FS Date: 4/2/2015

Pipe just visible on LS slope.

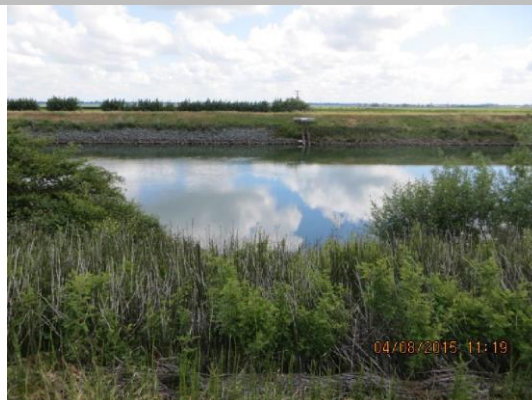
Photo 2 of 3 : UCIP\_FA\_2019\_46172\_74554.jpg

View of WS from shoulder at crossing. Pipe not found on WS.

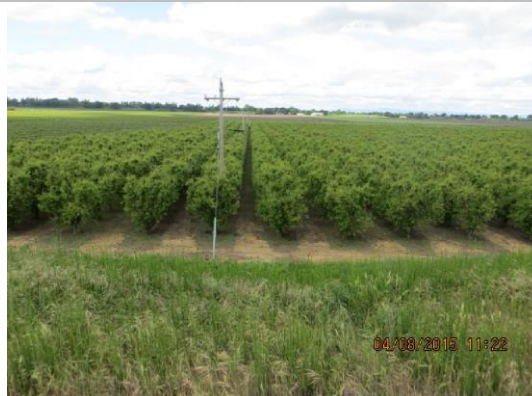
Photo 3 of 3 : UCIP\_FA\_2019\_46172\_74555.jpg

LM Start	3.15	Rating **	M	Issue No.	127 (cont)	
LM End	3.15	Issue Type +	En	Location *		
Category	Supplemental			GPS Latitude/Longitude		
				Start	End	
Item	DRAFT DWR UCIP Field Study			38.265608 °	38.265608 °	
				-121.588391 °	-121.588391 °	
DWR ID	25099					
Comment Code						
Inspector Comment						
DS_ID:25099						
FS_ID:46172						
EP_NO: N/A						
Repair Type: Non-Urgent						
Crossing Status: Found						
UCIP Comments: Appears abandoned and if so should be verified as having been done so properly.						
FIELD_STRUCT_DESC: *ABANDONED* 6-inch pipe of unknown material or purpose through the levee, 4.5 feet below the levee crown.						
Service pole at landside (LS) toe.						
FS Date: 4/2/2015

Approximate pipe alignment on LS.

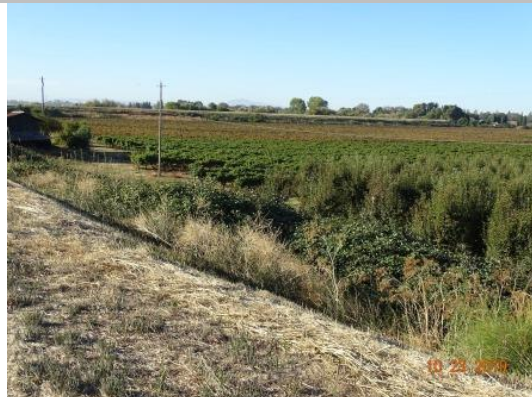
Photo 1 of 1 : FA\_2019\_RD0349\_205\_101\_20191025\_00131.jpg

LM Start	3.16	Rating **	U	Issue No.	101
LM End	3.18	Issue Type +	Ma	Location *	LS
Category	Earthen Levee			GPS Latitude/Longitude	
				Start	End
Item	Vegetation			38.265557 °	38.265143 °
				-121.588377 °	-121.588403 °
DWR ID	DWR_RD0349_02_s_2019_101				
Comment Code					
V2 : Remove the wild growth other than native grasses from the levee slopes.					
Inspector Comment

View looking downstream at thick blackberries at the bottom of the landside slope (Fall 2019).

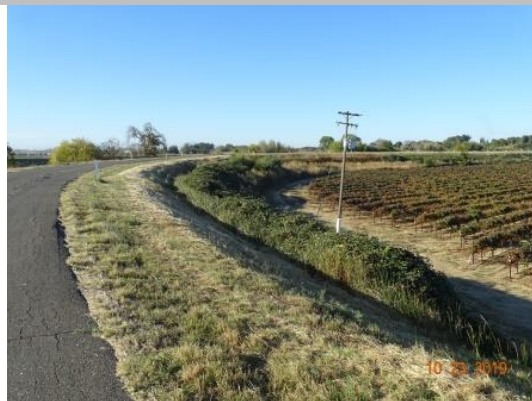
Photo 1 of 1 : FA\_2019\_RD0349\_205\_62\_20191025\_00132.jpg

LM Start	3.29	Rating **	M	Issue No.	62
LM End	3.60	Issue Type +	Ma	Location *	LS
Category	Earthen Levee			GPS Latitude/Longitude	
				Start	End
Item	Vegetation			38.263594 °	38.262449 °
				-121.588629 °	-121.593726 °
DWR ID	DWR_RD0349_02_f_2018_62				
Comment Code					
V2 : Remove the wild growth other than native grasses from the levee slopes.					
Inspector Comment					
Remove thick berry vines that completely block inspection and access to toe.

View looking downstream at thick blackberries on the bottom of the landside slope (Fall 2019).

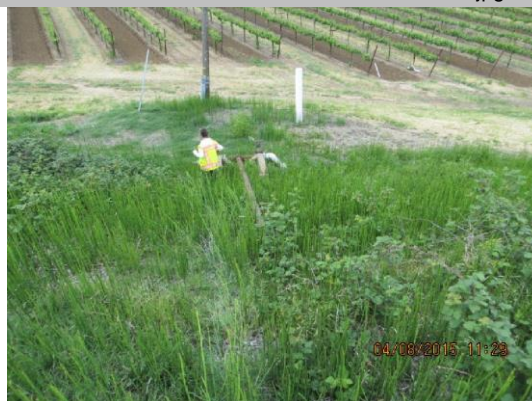
Photo 1 of 3 : UCIP\_FA\_2019\_44333\_73713.jpg

LM Start	3.31	Rating **	M	Issue No.	128	
LM End	3.31	Issue Type +	En	Location *		
Category	Supplemental			GPS Latitude/Longitude		
				Start		End
Item	DRAFT DWR UCIP Field Study			38.263359 °		38.263359 °
				-121.588721 °		-121.588721 °
DWR ID	24161					
Comment Code						
Inspector Comment						
DS_ID:24161 FS_ID:44333 EP_NO: N/A Repair Type: Non-Urgent Crossing Status: Found UCIP Comments: Pipe appears abandoned and if so should be done so properly. FIELD_STRUCT_DESC: *ABANDONED* 6-inch irrigation pipe of unknown material through the levee, 4.5 feet below the crown. Pump and switch panel located on the waterside (WS) slope. Service pole and concrete distribution box at landside (LS) toe. [Additional Reference(s): DWR Levee Log, 2005. USACE Sacramento O&M Manual Unit No. 110, May 1959, revised 29 Dec 2016, (HLM 3.5)] FS Date: 4/8/2015

Pipe, distribution box, and power pole visible on LS slope/toe.

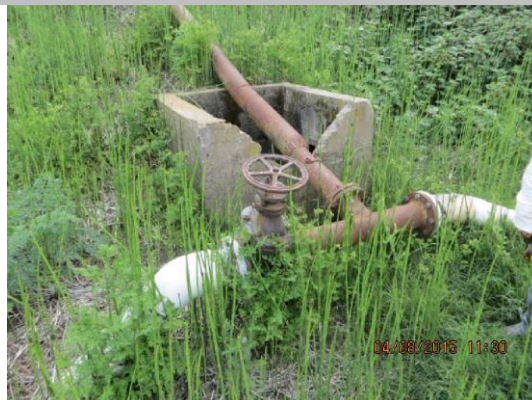
Photo 2 of 3 : UCIP\_FA\_2019\_44333\_73712.jpg

distribution box and pipe visible on LS toe.

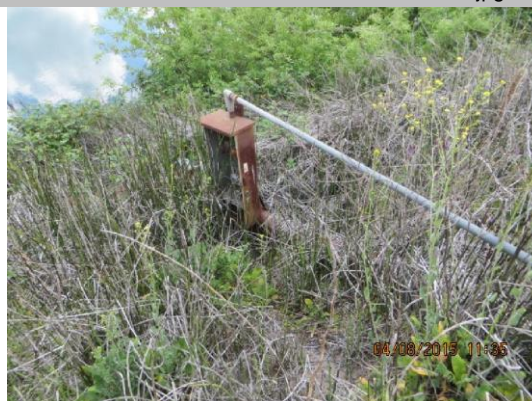
Photo 3 of 3 : UCIP\_FA\_2019\_44333\_73711.jpg

Comment Code						
Inspector Comment						
DS_ID:24161						
FS_ID:44333						
EP_NO: N/A						
Repair Type: Non-Urgent						
Crossing Status: Found						
UCIP Comments: Pipe appears abandoned and if so should be done so properly.						
FIELD_STRUCT_DESC: *ABANDONED* 6-inch irrigation pipe of unknown material through the levee, 4.5 feet below the crown. Pump and switch panel located on the waterside (WS) slope. Service pole and concrete distribution box at landside (LS) toe. [Additional Reference(s): DWR Levee Log, 2005. USACE Sacramento O&M Manual Unit No. 110, May 1959, revised 29 Dec 2016, (HLM 3.5)]						
FS Date: 4/8/2015

Pipe and electrical conduit visible on WS slope.

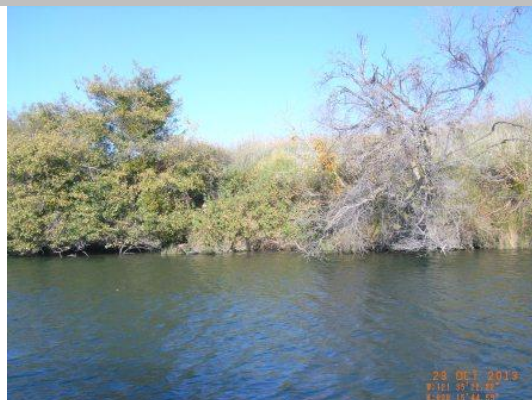
Photo 1 of 1 : FA\_2019\_RD0349\_205\_23\_20190826\_00007.jpg

LM Start	3.38	Rating **	M	Issue No.	23
LM End	3.49	Issue Type +	Ma	Location *	WS
Category	Supplemental			GPS Latitude/Longitude	
				Start	End
Item	2017 USACE Erosion Survey			38.262510 °	38.262533 °
				-121.589481 °	-121.591690 °
DWR ID	DWR_RD0349_02_f_2018_23				
Comment Code					
Inspector Comment					
2017 Site ID: STM 22.8 R					
Status: Eroding					
2017 Field Notes: No observed change.					
Site History: 2010 - Slumping sections on the lower bank, appears to be scouring around the trees. 2011 - Soil beach at toe.

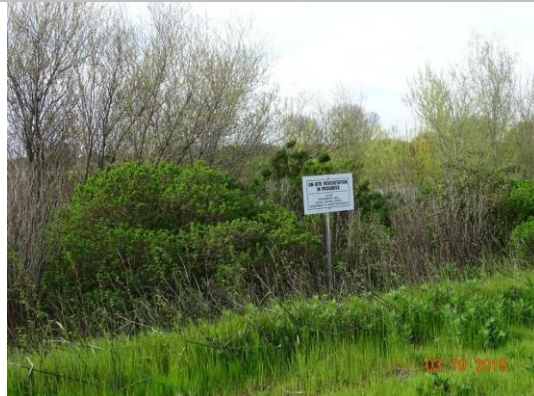
Photo 1 of 1 : FA\_2019\_RD0349\_205\_103\_20190826\_00062.jpg

LM Start	3.50	Rating **	A/W	Issue No.	103
LM End	3.57	Issue Type +	Ob	Location *	WS
Category	Earthen Levee			GPS Latitude/Longitude	
				Start	End
Item	Vegetation			38.262743 °	38.262620 °
				-121.591877 °	-121.593085 °
DWR ID	DWR_RD0349_02_s_2019_103				
Comment Code					
V8 : Environmental Requirements.					
Inspector Comment					
Revegetation site

View of revegetation site sign (Spring 2019).

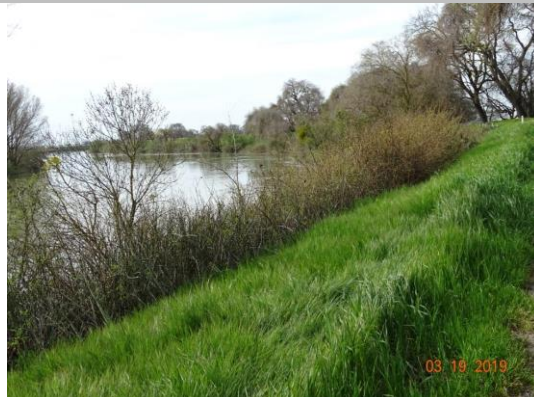
Photo 1 of 1 : FA\_2019\_RD0349\_205\_104\_20190826\_00063.jpg

LM Start	3.64	Rating **	U	Issue No.	104
LM End	3.67	Issue Type +	Ma	Location *	WS
Category	Earthen Levee			GPS Latitude/Longitude	
				Start	End
Item	Vegetation			38.262068 °	38.261835 °
				-121.594283 °	-121.594553 °
DWR ID	DWR_RD0349_02_s_2019_104				
Comment Code					
V2 : Remove the wild growth other than native grasses from the levee slopes.					
Inspector Comment					
Wild growth is blocking the view down the waterside slope.

View looking downstream at wild growth on the waterside slope (Spring 2019).

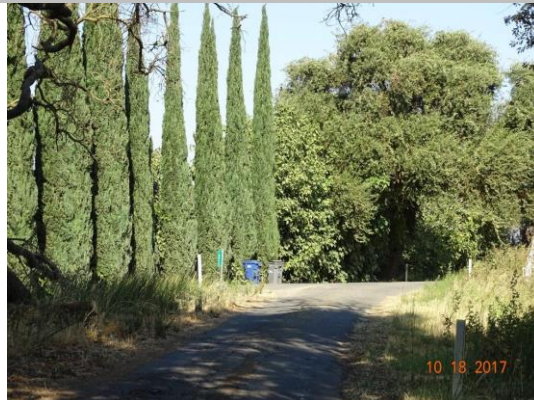
Photo 1 of 1 : FA\_2019\_RD0349\_205\_65\_20190826\_00048.jpg

LM Start	3.66	Rating **	M	Issue No.	65
LM End	3.66	Issue Type +	En	Location *	LS
Category	Earthen Levee			GPS Latitude/Longitude	
				Start	End
Item	Vegetation			38.261933 °	38.261933 °
				-121.594549 °	-121.594549 °
DWR ID	DWR_RD0349_02_f_2017_65				
Comment Code					
V6 : Landscaping					
Inspector Comment					
Trim/thin fig trees and evergreen shrubs to allow visibility and access to levee slope.

View of fig trees and evergreen shrubs on the landside levee slope

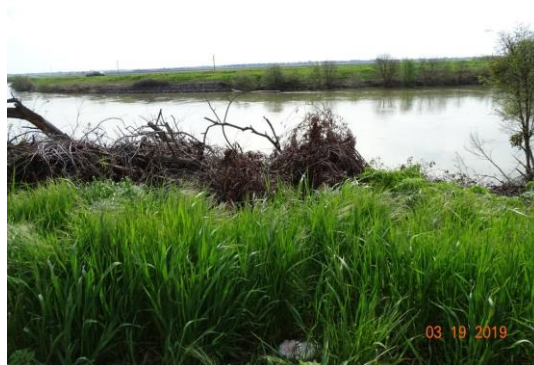
Photo 1 of 1 : FA\_2019\_RD0349\_205\_47\_20190826\_00037.jpg

LM Start	3.67	Rating **	U	Issue No.	47
LM End	3.67	Issue Type +	En	Location *	WS
Category	Earthen Levee			GPS Latitude/Longitude	
				Start	End
Item	Encroachments			38.261815 °	38.261815 °
				-121.594600 °	-121.594600 °
DWR ID	DWR_RD0349_02_f_2018_47				
Comment Code					
PR : Prunings					
Inspector Comment					
Remove prunings from the waterside shoulder.

View of prunings on the waterside shoulder (Spring 2019).

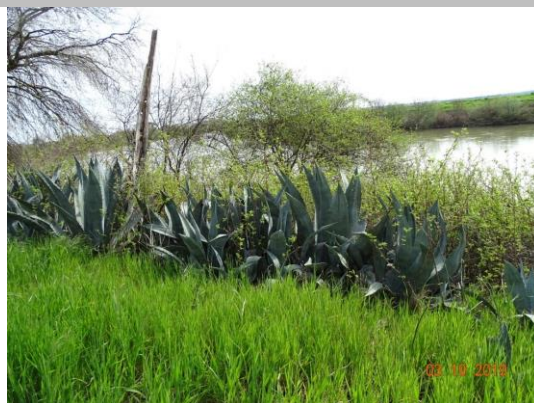
Photo 1 of 1 : FA\_2019\_RD0349\_205\_64\_20190826\_00047.jpg

LM Start	3.71	Rating **	U	Issue No.	64
LM End	3.72	Issue Type +	En	Location *	WS
Category	Earthen Levee			GPS Latitude/Longitude	
				Start	End
Item	Vegetation			38.261252 °	38.261143 °
				-121.595012 °	-121.595071 °
DWR ID	DWR_RD0349_02_s_2018_64				
Comment Code					
V6 : Landscaping					
Inspector Comment					
Remove cactus (century plants) from the waterside shoulder.

View of cactus on the waterside shoulder (Spring 2019).

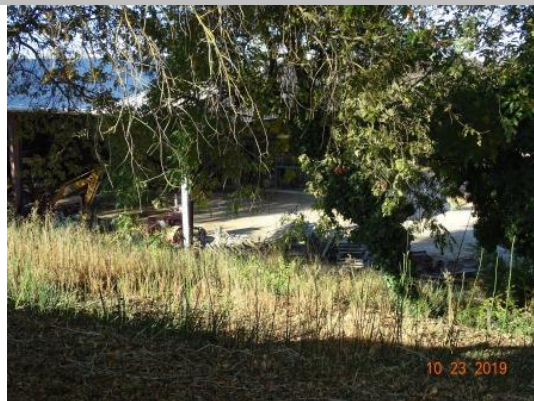
Photo 1 of 1 : FA\_2019\_RD0349\_205\_68\_20191025\_00133.jpg

LM Start	3.72	Rating **	M	Issue No.	68
LM End	3.72	Issue Type +	En	Location *	LS
Category	Earthen Levee			GPS Latitude/Longitude	
				Start	End
Item	Encroachments			38.261128 °	38.261128 °
				-121.595080 °	-121.595080 °
DWR ID	DWR_RD0349_02_s_2018_68				
Comment Code					
EQ : Equipment					
Inspector Comment					
Remove metal pipe (12" dia x 35' long) from landside shoulder.

View looking downslope at farm equipment at the landside toe (Fall 2019).

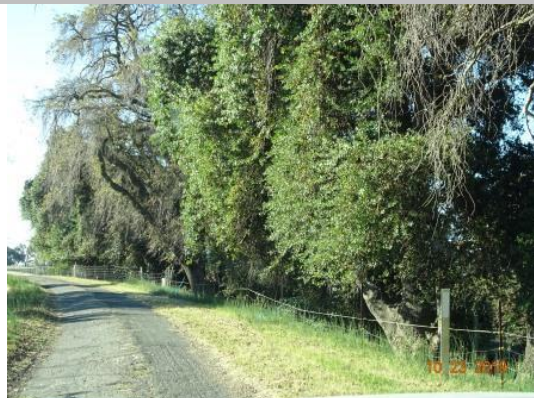
Photo 1 of 1 : FA\_2019\_RD0349\_205\_59\_20191025\_00134.jpg

LM Start	3.76	Rating **	U	Issue No.	59
LM End	3.93	Issue Type +	En	Location *	LS
Category	Earthen Levee			GPS Latitude/Longitude	
				Start	End
Item	Encroachments			38.260596 °	38.258123 °
				-121.592160 °	-121.595150 °
DWR ID	DWR_RD0349_02_f_2013_59				
Comment Code					
FE : Fence					
Inspector Comment					
Inside the fenced off area are several pet shelters and pens for chickens and goats on the landside levee slope and toe. These need to be removed from the levee section. In the event of a flood fight this area would cause delays in response time.

View looking downstream at unauthorized electric fence on the landside slope (Fall 2019).

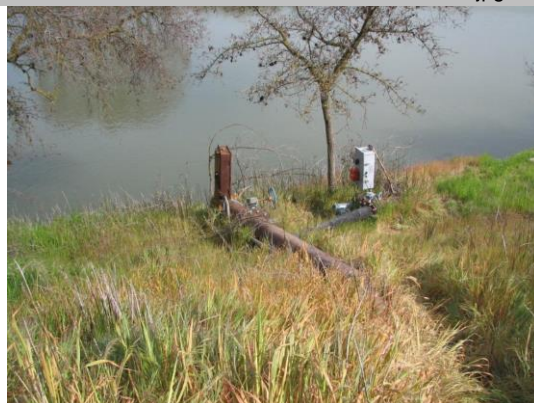
Photo 1 of 3 : UCIP\_FA\_2019\_21612\_36684.jpg

Comment Code					
Inspector Comment					
DS_ID:24162 FS_ID:21612 EP_NO: 8188 Repair Type: Non-Urgent Crossing Status: Found UCIP Comments: Dense vegetation limits the inspector's visibility to identify signs of pipe failure (leaks) along the landward slope. Recommend removing vegetation along pipe alignment to conduct proper inspection of structure and appurtenances. Unable to determine if crossing is in use. Note date on photos should be 3/18/09 not 7/26/08 camera metadata is incorrect. FIELD_STRUCT_DESC: 12-inch steel irrigation pipe and 1.25-inch electrical conduit through the levee, 5.0 feet below the levee crown. Steel cutoff wall around pipe at center of levee. Siphon breaker on shoulder. Pump and pump house on the waterside (WS). Service pole, discharge box and concrete standpipe at landside (LS) toe. (12-inch pipe authorized under Permit No. 8188, 1973 - E. Salman, 10-inch pipe removed) [Additional Reference(s): DWR Levee Log, 2005] FS Date: 3/18/2009

Overview of waterward side--2 crossings.

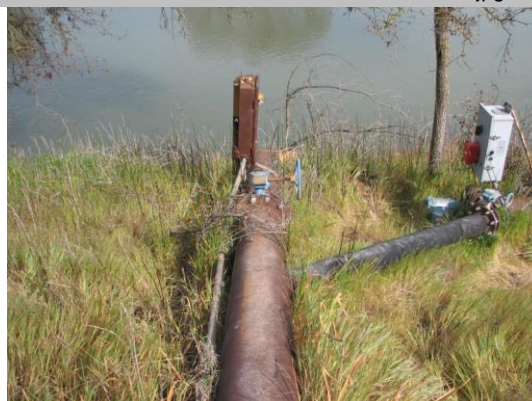
Photo 2 of 3 : UCIP\_FA\_2019\_21612\_36682.jpg

DS\_ID:24162  
FS\_ID:21612  
EP\_NO: 8188  
Repair Type: Non-Urgent  
Crossing Status: Found  
UCIP Comments: Dense vegetation limits the inspector's visibility to identify signs of pipe failure (leaks) along the landward slope. Recommend removing vegetation along pipe alignment to conduct proper inspection of structure and appurtenances. Unable to determine if crossing is in use. Note date on photos should be 3/18/09 not 7/26/08 camera metadata is incorrect.  
FIELD\_STRUCT\_DESC: 12-inch steel irrigation pipe and 1.25-inch electrical conduit through the levee, 5.0 feet below the levee crown. Steel cutoff wall around pipe at center of levee. Siphon breaker on shoulder. Pump and pump house on the waterside (WS). Service pole, discharge box and concrete standpipe at landside (LS) toe. (12-inch pipe authorized under Permit No. 8188, 1973 - E. Salman, 10-inch pipe removed) [Additional Reference(s): DWR Levee Log, 2005]

View of crossing on waterward side.

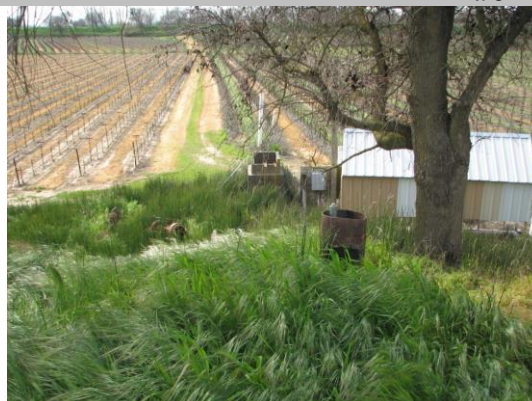
Photo 3 of 3 : UCIP\_FA\_2019\_21612\_36683.jpg

Overview of landward side--appurtenances include distribution box, stand pipe, pump house, and control panel.

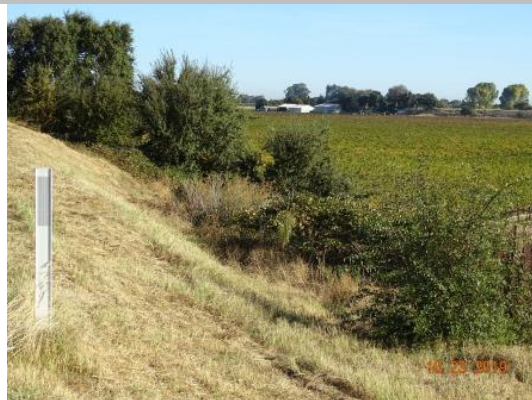
Photo 1 of 1 : FA\_2019\_RD0349\_206\_34\_20191025\_00090.jpg

LM Start	0.02	Rating **	U	Issue No.	34
LM End	0.21	Issue Type +	Ma	Location *	LS
Category	Earthen Levee			GPS Latitude/Longitude	
				Start	End
Item	Vegetation			38.255025 °	38.257803 °
				-121.600078 °	-121.599805 °
DWR ID	DWR_RD0349_03_s_2019_34				
Comment Code					
V2 : Remove the wild growth other than native grasses from the levee slopes.					
Inspector Comment

View looking upstream at vegetation on the landside slope (Fall 2019).

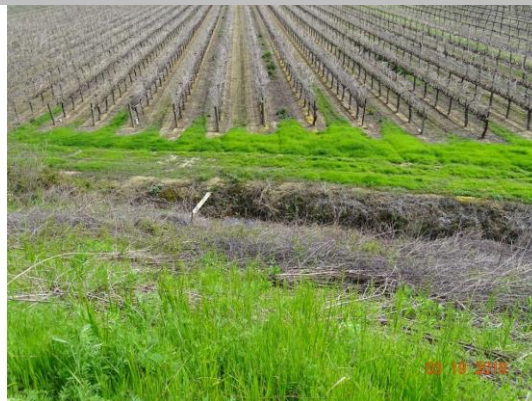
Photo 1 of 1 : FA\_2019\_RD0349\_206\_41\_20190826\_00005.jpg

LM Start	0.21	Rating **	U	Issue No.	41
LM End	0.21	Issue Type +	En	Location *	LS
Category	Earthen Levee			GPS Latitude/Longitude	
				Start	End
Item	Encroachments			38.257803 °	38.257803 °
				-121.599805 °	-121.599805 °
DWR ID	DWR_RD0349_03_s_2019_41				
Comment Code					
DT : Ditch					
Inspector Comment					
Ditch located along the landside toe.

View of ditch at the landside toe (Spring 2019).

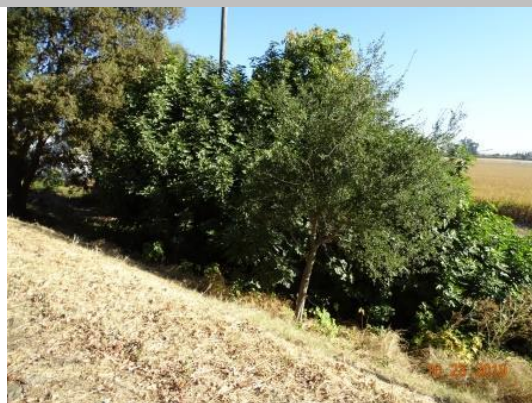
Photo 1 of 1 : FA\_2019\_RD0349\_206\_8\_20191025\_00091.jpg

LM Start	0.76	Rating **	U	Issue No.	8
LM End	0.76	Issue Type +	Ma	Location *	LS
Category	Earthen Levee			GPS Latitude/Longitude	
				Start	End
Item	Trim / Thin Trees			38.265637 °	38.265637 °
				-121.601640 °	-121.601640 °
DWR ID	DWR_RD0349_03_f_2017_8				
Comment Code					
T2 : Thin trees to allow visibility of the ground and room to flood fight.					
Inspector Comment					
Trim large fig tree to allow visibility and access to landside levee slope.

View looking upstream at fig tree on the landside slope (Fall 2019).

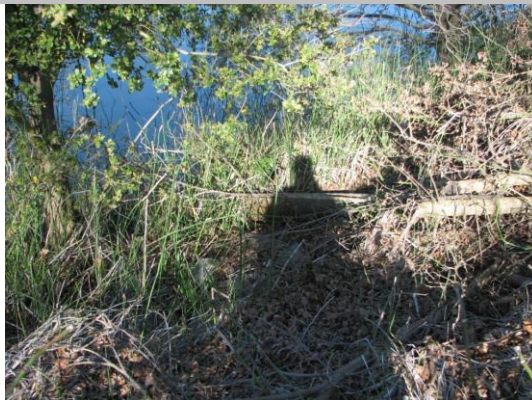
Photo 1 of 3 : UCIP\_FA\_2019\_43442\_36707.jpg

Comment Code						
Inspector Comment						
DS_ID:24163						
FS_ID:43442						
EP_NO: N/A						
Repair Type: Non-Urgent						
Crossing Status: Found						
UCIP Comments: Need to find owner and notify of pipe deterioration. Owner will need to replace or remove per CVFPB Title 23 requirements. Dense vegetation limits the inspector's visibility to identify signs of pipe failure (leaks) through the levee slopes. Recommend removing vegetation along pipe alignment to conduct proper inspection of structure and appurtenances. Note date on photos should be 3/18/09 not 7/26/08 camera metadata is incorrect.						
FIELD_STRUCT_DESC: 8-inch steel irrigation pipe through the levee, 2.4 feet below the crown. Pump and gate valve in a pump house at the landside (LS) toe. Concrete standpipe on LS. [Additional Reference(s): DWR Levee Log, 2005]						
FS Date: 3/19/2009

View of waterward side--portion of pipe exposed on slope.

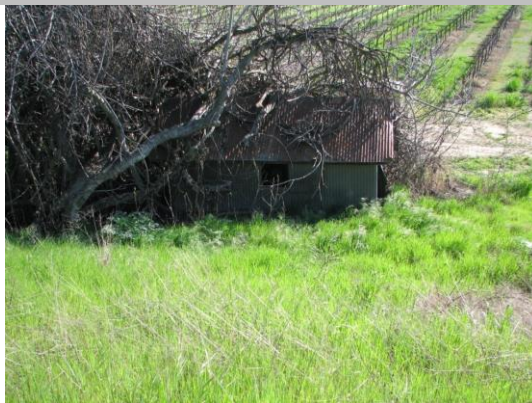
Photo 2 of 3 : UCIP\_FA\_2019\_43442\_36706.jpg

Pump house located at the landward toe.

Comment Code						
Inspector Comment						
DS_ID:24163						
FS_ID:43442						
EP_NO: N/A						
Repair Type: Non-Urgent						
Crossing Status: Found						
UCIP Comments: Need to find owner and notify of pipe deterioration. Owner will need to replace or remove per CVFPB Title 23 requirements. Dense vegetation limits the inspector's visibility to identify signs of pipe failure (leaks) through the levee slopes. Recommend removing vegetation along pipe alignment to conduct proper inspection of structure and appurtenances. Note date on photos should be 3/18/09 not 7/26/08 camera metadata is incorrect.						
FIELD_STRUCT_DESC: 8-inch steel irrigation pipe through the levee, 2.4 feet below the crown. Pump and gate valve in a pump house at the landside (LS) toe. Concrete standpipe on LS. [Additional Reference(s): DWR Levee Log, 2005]						
FS Date: 3/19/2009

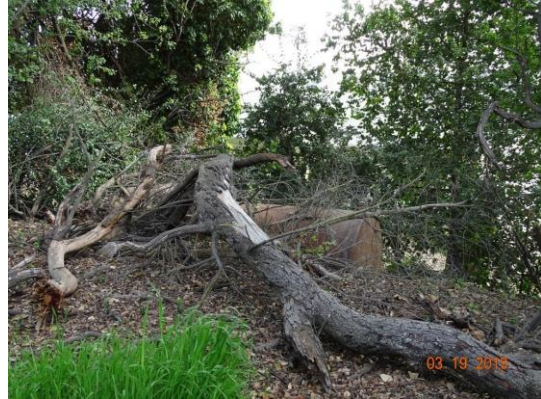
Photo 1 of 1 : FA\_2019\_RD0349\_206\_44\_20190826\_00007.jpg

LM Start	0.80	Rating **	M	Issue No.	44
LM End	0.80	Issue Type +	En	Location *	LS
Category	Earthen Levee			GPS Latitude/Longitude	
				Start	End
Item	Encroachments			38.266168 °	38.266168 °
				-121.601834 °	-121.601834 °
DWR ID	DWR_RD0349_03_s_2018_44				
Comment Code					
TA : Tank					
Inspector Comment					
A 300 gallon metal tank is located on shoulder.

View of tank on the land side shoulder (Spring 2019).

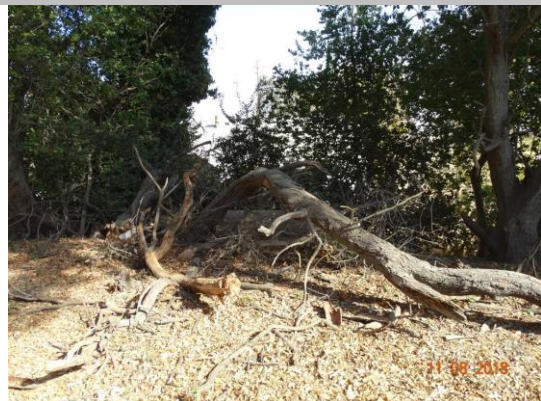
Photo 1 of 1 : FA\_2019\_RD0349\_206\_67\_20190826\_00017.jpg

LM Start	0.80	Rating **	M	Issue No.	67
LM End	0.80	Issue Type +	Ma	Location *	LS
Category	Earthen Levee			GPS Latitude/Longitude	
				Start	End
Item	Encroachments			38.266201 °	38.266201 °
				-121.601832 °	-121.601832 °
DWR ID	DWR_RD0349_03_s_2018_67				
Comment Code					
TR : Tree or limb					
Inspector Comment					
Trees and limbs on landside shoulder and slope need to be cleared out to allow inspection and access.

View of down tree on the land side shoulder (November 2018).

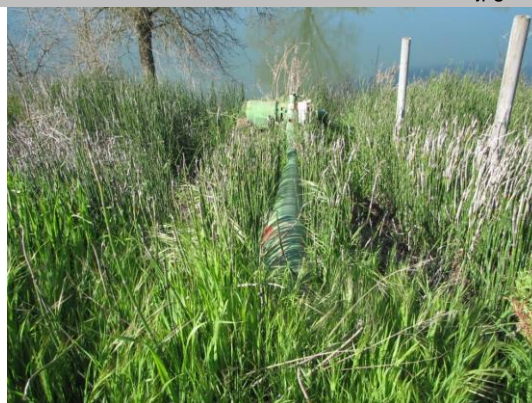
Photo 1 of 3 : UCIP\_FA\_2019\_21673\_36851.jpg

Comment Code						
Inspector Comment						
DS_ID:24232						
FS_ID:21673						
EP_NO: N/A						
Repair Type: Non-Urgent						
Crossing Status: Found						
UCIP Comments: No records were found during initial desk study--need to contact owner to obtain permit number authorizing work. Unable to determine if filter system is part of crossing appurtenances. If crossing is no longer used by owner, the owner will need to coordinate with DWR Inspector and CVFPB to remove crossing according to Title 23 requirements. Dense vegetation limits the inspector's visibility to identify signs of pipe failure (leaks) through the levee slopes. Recommend removing vegetation along pipe alignment to conduct proper inspection of structure and appurtenances. Note date on photos should be 3/18/09 not 7/26/08 camera metadata is incorrect.						
FIELD_STRUCT_DESC: 12-inch steel irrigation pipe through the levee, 2.0 feet below the levee crown. Pipe changes diameter, 10-inch along both shoulders and 8-inch diameter exit on waterside (WS). Pipe exposed along both slopes. Pump on WS. Filtration system and power pole on landside (LS). Rock revetment along WS slope.

View of waterward side--pipe and pump.

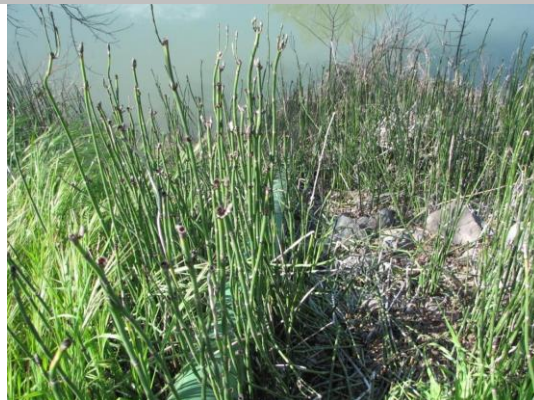
Photo 2 of 3 : UCIP\_FA\_2019\_21673\_36853.jpg

DS\_ID:24232  
FS\_ID:21673  
EP\_NO: N/A  
Repair Type: Non-Urgent  
Crossing Status: Found  
UCIP Comments: No records were found during initial desk study--need to contact owner to obtain permit number authorizing work. Unable to determine if filter system is part of crossing appurtenances. If crossing is no longer used by owner, the owner will need to coordinate with DWR Inspector and CVFPB to remove crossing according to Title 23 requirements. Dense vegetation limits the inspector's visibility to identify signs of pipe failure (leaks) through the levee slopes. Recommend removing vegetation along pipe alignment to conduct proper inspection of structure and appurtenances. Note date on photos should be 3/18/09 not 7/26/08 camera metadata is incorrect.  
FIELD\_STRUCT\_DESC: 12-inch steel irrigation pipe through the levee, 2.0 feet below the levee crown. Pipe changes diameter, 10-inch along both shoulders and 8-inch diameter exit on waterside (WS). Pipe exposed along both slopes. Pump on WS. Filtration system and power pole on landside (LS). Rock revetment along WS slope.

View of pipe crossing past pump station.

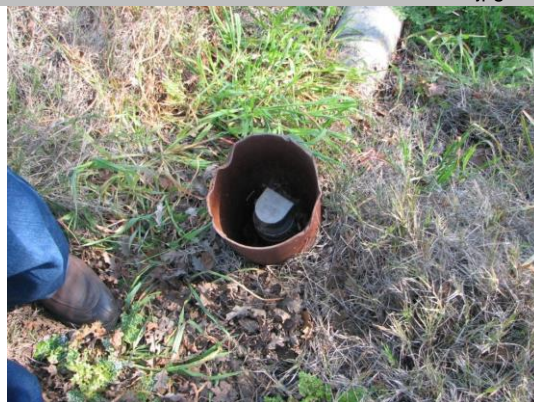
Photo 3 of 3 : UCIP\_FA\_2019\_21673\_36852.jpg

View of siphon breaker.

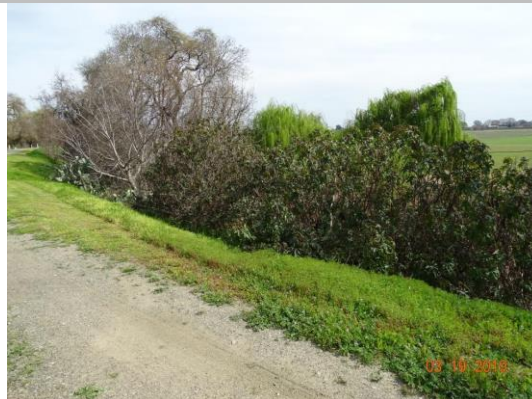
Photo 1 of 1 : FA\_2019\_RD0349\_206\_49\_20190826\_00011.jpg

LM Start	1.08	Rating **	U	Issue No.	49
LM End	1.09	Issue Type +	En	Location *	LS
Category	Earthen Levee			GPS Latitude/Longitude	
				Start	End
Item	Vegetation			38.270022 °	38.270158 °
				-121.603572 °	-121.603579 °
DWR ID	DWR_RD0349_03_s_2019_49				
Comment Code					
V6 : Landscaping					
Inspector Comment					
Remove cactus from landside slope.

View of cactus on the landside slope (Spring 2019).

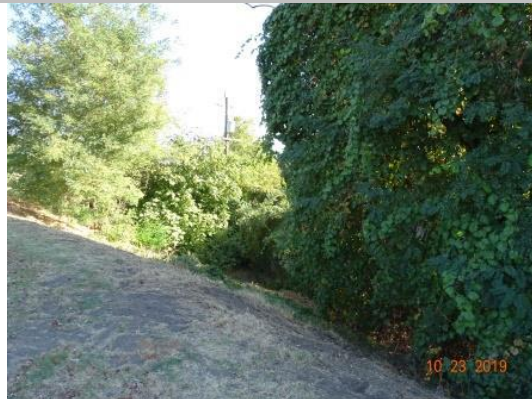
Photo 1 of 1 : FA\_2019\_RD0349\_206\_51\_20191025\_00092.jpg

LM Start	1.11	Rating **	U	Issue No.	51
LM End	1.13	Issue Type +	Ma	Location *	LS
Category	Earthen Levee			GPS Latitude/Longitude	
				Start	End
Item	Trim / Thin Trees			38.270452 °	38.270677 °
				-121.603587 °	-121.603572 °
DWR ID	DWR_RD0349_03_f_2017_51				
Comment Code					
T1 : Trim trees to at least five feet above ground level.					
Inspector Comment

View looking upstream at untrimmed trees on the landside slope (Fall 2019).
